SALEM SOUND COASTWATCH

Salem Sound Clean Beaches and Streams Program Report for April through August, 2007

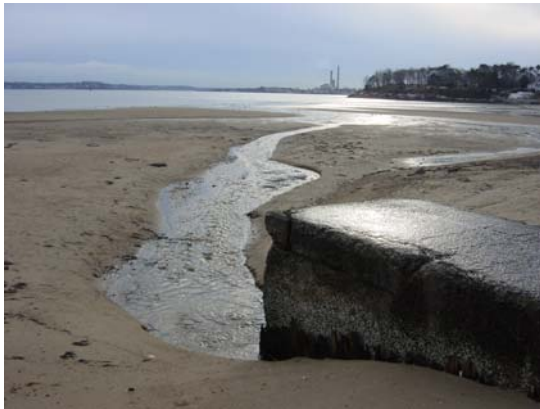
#213 – Patch Beach, Beverly

Because bacterial contamination at Patch (Brackenbury) Beach has been high for the past few years, a Sanitary Beach Survey was undertaken in 2004 and 2005 by EPA New England. In 2006, SSCW continued to sample and found that the highest levels of bacteria coming from the two outfall pipes (#213 & #213A) occurred during the higher tides associated with the full moon. SSCW has begun working on EPA's recommendations by partnering with landowners including Endicott College, MA Coastal Zone Management Wetlands Restoration Program, and the City of Beverly to restore tidal flushing to the adjacent salt marsh. While the restoration is being developed and permitted, SSCW has expanded its water testing to include more Centerville Brook sites to identify the bacterial sources.

The water then travels through an open three-sided channel before entering a granite culvert that has opening to the salt marsh and exits on to the beach. Although numbers are still high, the bacterial levels are lower at the outfall mouth than from the stream right after the duck area.

#213	120	80	550	380	NS	1,000	6,400	5,200	1,200	940	1,200
------	-----	----	-----	-----	----	-------	-------	-------	-------	-----	-------

Waterfowl are a known source of bacterial pollution, particularly when they congregate in large numbers. The persistent feeding of ducks is contributing to increased bacterial pollution downstream and should be addressed by the Beverly Board of Health.

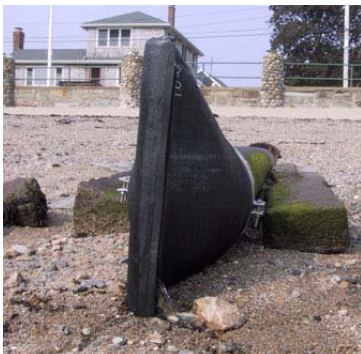
#620 – Juniper Beach, Salem

In 2006, the Juniper Beach outfall (#620) started off the sampling season with the same record high numbers as in the past (16,740 CFU/100mL). But after the Salem DPW cleaned the pipe and installed a

TideFlex “duckbill” tide gate, the numbers dropped into the low hundreds, a dramatic improvement. In the spring test results were in the low range from <10 to 40 CFU/100mL and the majority of tests were in this range through August except for two days. On June 14th, bacterial counts were 3,600 CFU/100mL and on August 30 they were 7,000 CFU/100mL. Both these days were dry weather sampling (Note that the two wet samplings had counts of 10 and 680 CFU/100mL). One idea that needs to be investigated further is the relationship of tide elevation and bacterial counts. There was a new moon on June 15th and a full moon on August 28th. Perhaps the higher tides forced more water through the duckbill tide gate and the water reached further up the outfall pipe.

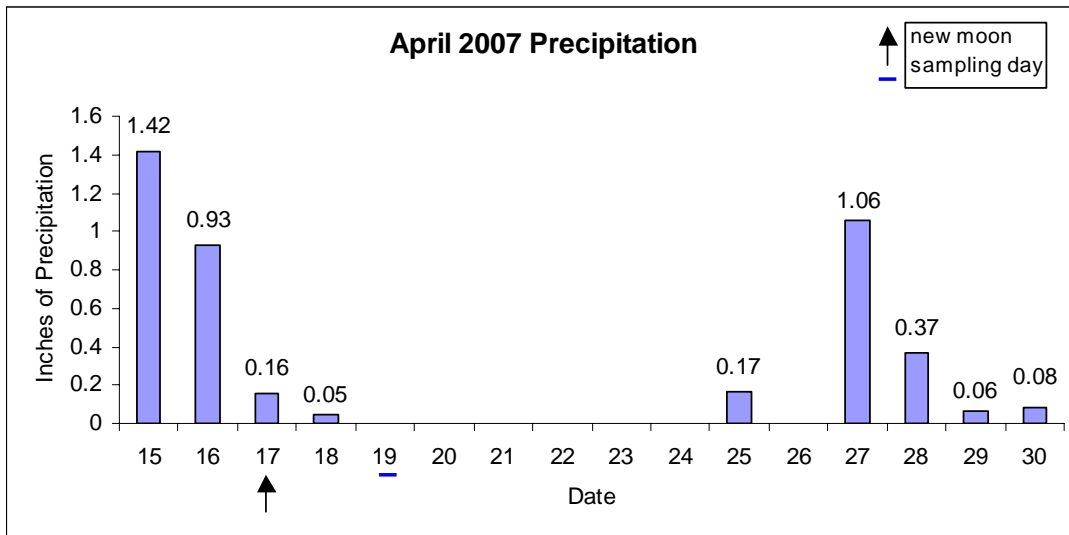
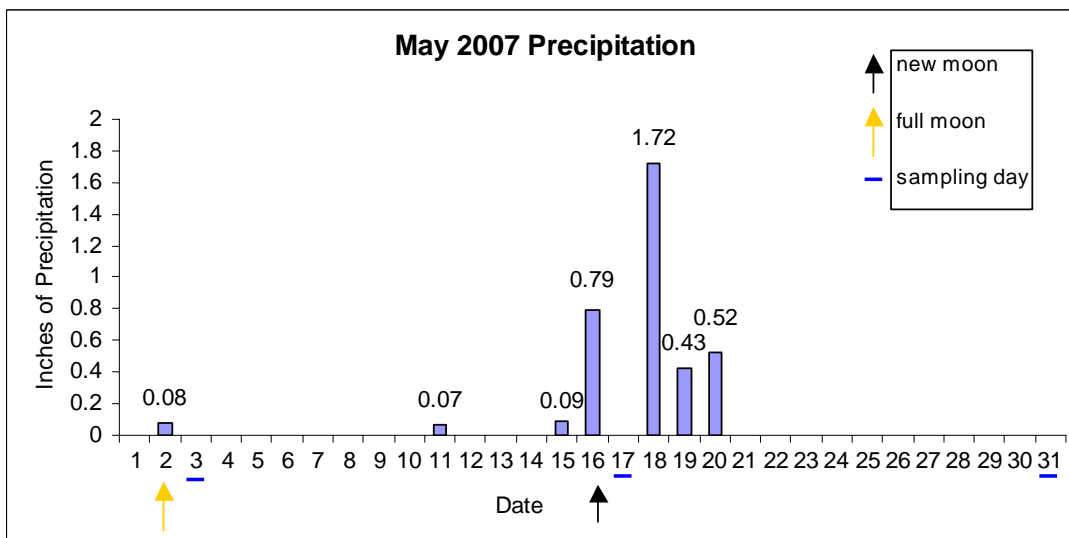
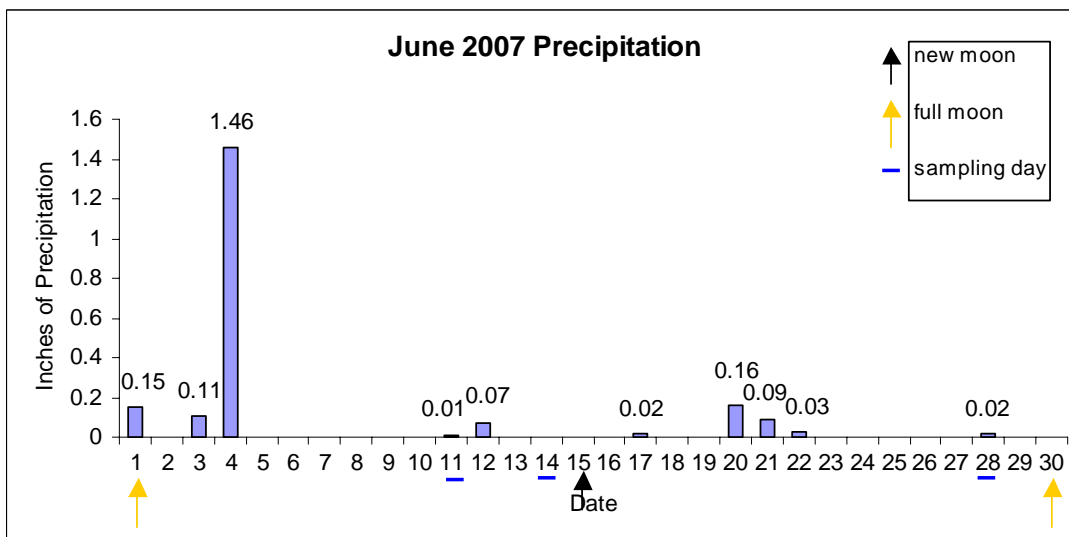
Graphs 1: Precipitation recorded at the Beverly Airport for April, May and June.

SSCW defines “dry” conditions vs. “wet” differently than the municipalities. Under SSCW’s definition, **dry conditions are less than 0.2" precipitation the day of sampling or less than 0.5" within the three days preceding sampling. Wet conditions are defined as more than 0.2" precipitation on the day of sampling or more than .5" within three days preceding sampling.** Protocols for wet weather sampling are the same as for dry weather sampling. Graphs 1 & 2 show the precipitation for the sampling period.
