# SALEM SOUND COASTWATCH

## **Salem Sound Clean Beaches and Streams Program Report for June through August, 2016**

The following report is a summary of results from water quality testing that took place from June through August in Salem Sound Coastwatch's Clean Beaches and Streams Program. Table 9. displays results of tests performed by Salem Sound Coastwatch (SSCW) at coastal outfall pipes and streams. SSCW's water sampling follows a Department of Environmental Protection approved QAPP that was last revised July 7, 2006. All SSCW volunteer water samplers took the required training as spelled out in this QAPP. All sampling and chain of custody protocols were followed, and a completeness range of 90 to 100 percent of the samples for collection was met.

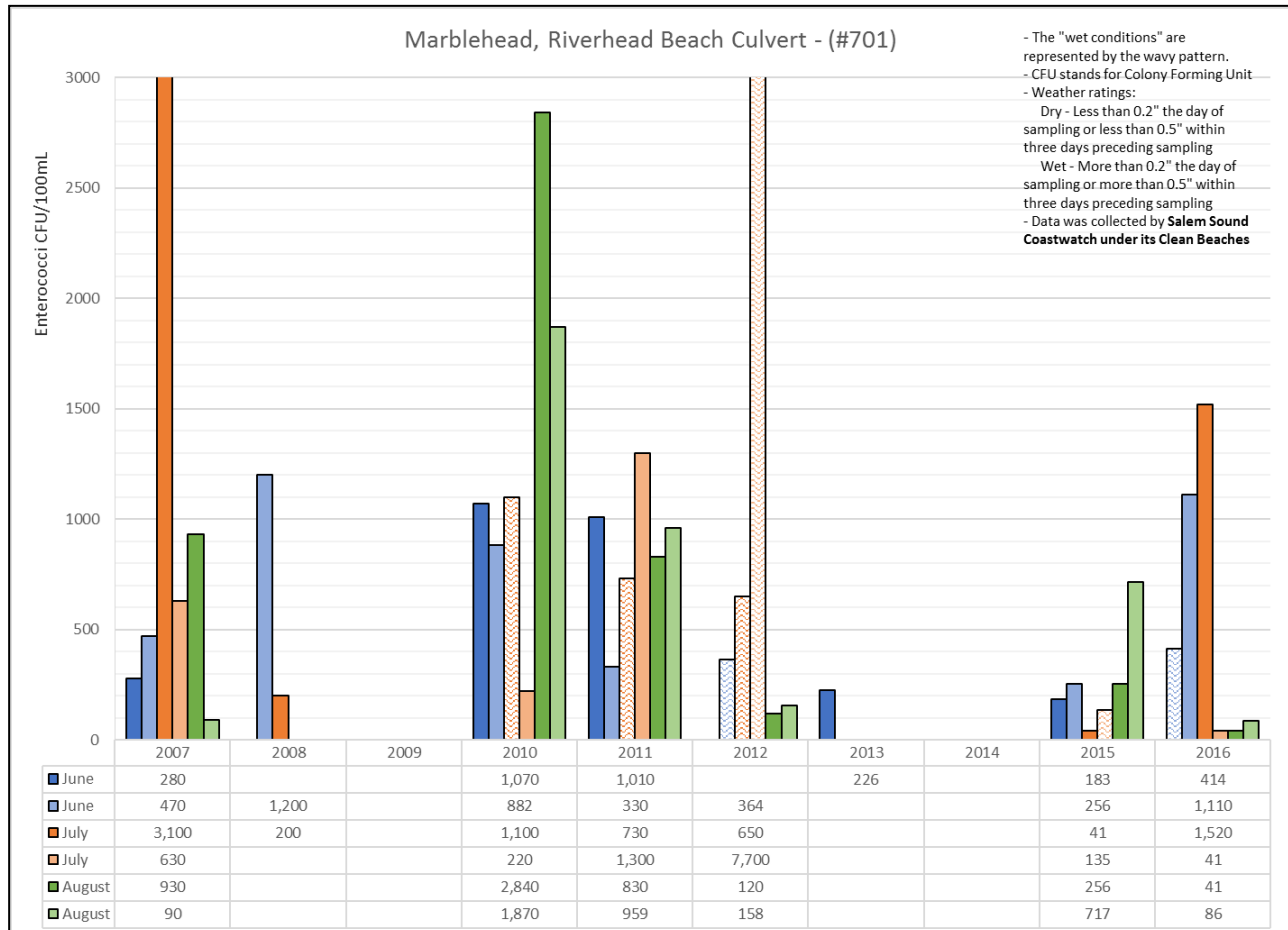
Figure 1. Graphic representation of Enterococcus results at Marblehead's Riverhead Beach Culvert 2007 to 2016.

In 2015 and 2016, SSCW returned to the Riverhead Beach culvert (#701) which drains much of the downtown area and the neighborhood around the Goldthwait salt marsh. The Marblehead Water and Sewer Commission conducted a large stormwater project in the downtown area, 2013 – 2014. The chart below shows a decrease in bacterial levels since this effort was made.

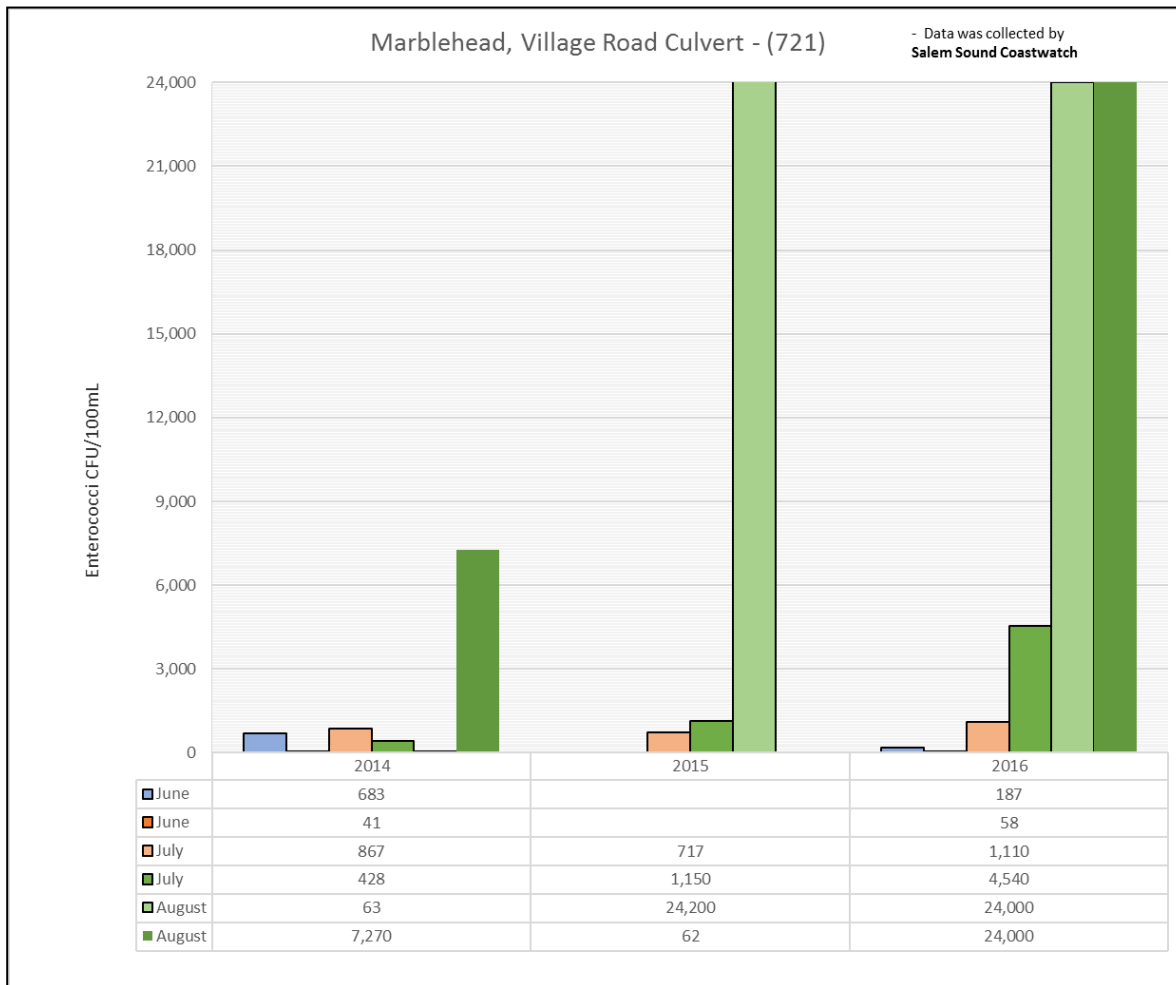
Figure 2. Graphic representation of Enterococcus results at Marblehead’s Village Street Culvert 2014 to 2016.

Village Road culvert (#721) was added to the Marblehead outfalls being monitored in 2014. The culvert was not sampled in June, 2015. Because of the extreme levels of bacteria – 24,000 CFU/100 mL at the last sampling date in August 2015 (not wet weather), sampling continued in 2016. Once again, high exceedances were seen in August. Salem Sound Coastwatch will work with the Marblehead Water and Sewer Commission to investigate the outfall’s watershed. Note that the lowest bacterial (58 CFU/100mL) was on a wet sampling date, June 23, 2016. Sampling should continue in 2017.
