Salem Sound Clean Beaches and Streams Program Report for Manchester-by-the-Sea, MA June through August 2024

The following report summarizes results from water quality testing from June through August in Salem Sound Coastwatch's Clean Beaches and Streams Program at coastal outfall pipes and streams. Salem Sound Coastwatch (SSCW) conducts water sampling following a Department of Environmental Protection-approved Quality Assurance Project Plan (QAPP last revised in 2024). All SSCW volunteer water technicians took the required training as spelled out in this QAPP. Sampling and chain of custody protocols were followed, and a minimum completeness range of 90 to 100 percent of the samples for collection was met.

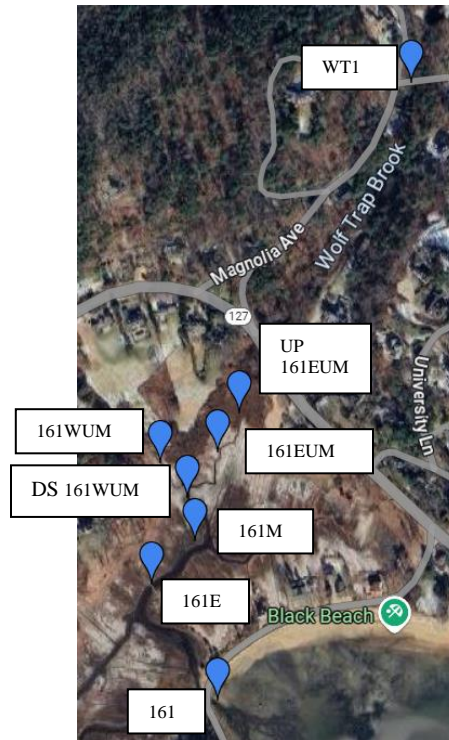
Map 2: 2024 Monitoring Sites in Manchester-by-the-Sea

Additional testing through the SSCW Tributary and Water Quality Monitoring Program was done in late August to determine where septic system leakage may be a problem. Those results follow in Table 3. Salem Sound Coastwatch and the Manchester Coastal Stream Team decided to test at the top of Wolf Trap Brook (WT1) and closer to the houses south of Route 127. If results were low before the brook entered the marsh, the source of contamination is not from Magnolia Avenue. Because 161-EUM (857) had higher bacterial counts (than the west 161-WUM (86), an effort was made to go through the phragmites toward Route 127 as far as possible without walking in the brook to avoid disturbing any possible contaminated sediment. The results showed few bacteria at WT1 (10/100mL) and significantly more at UP 161-EUM (1396/100mL). These results lead us to believe that there is a septic leak between the two testing sites warranting investigation.

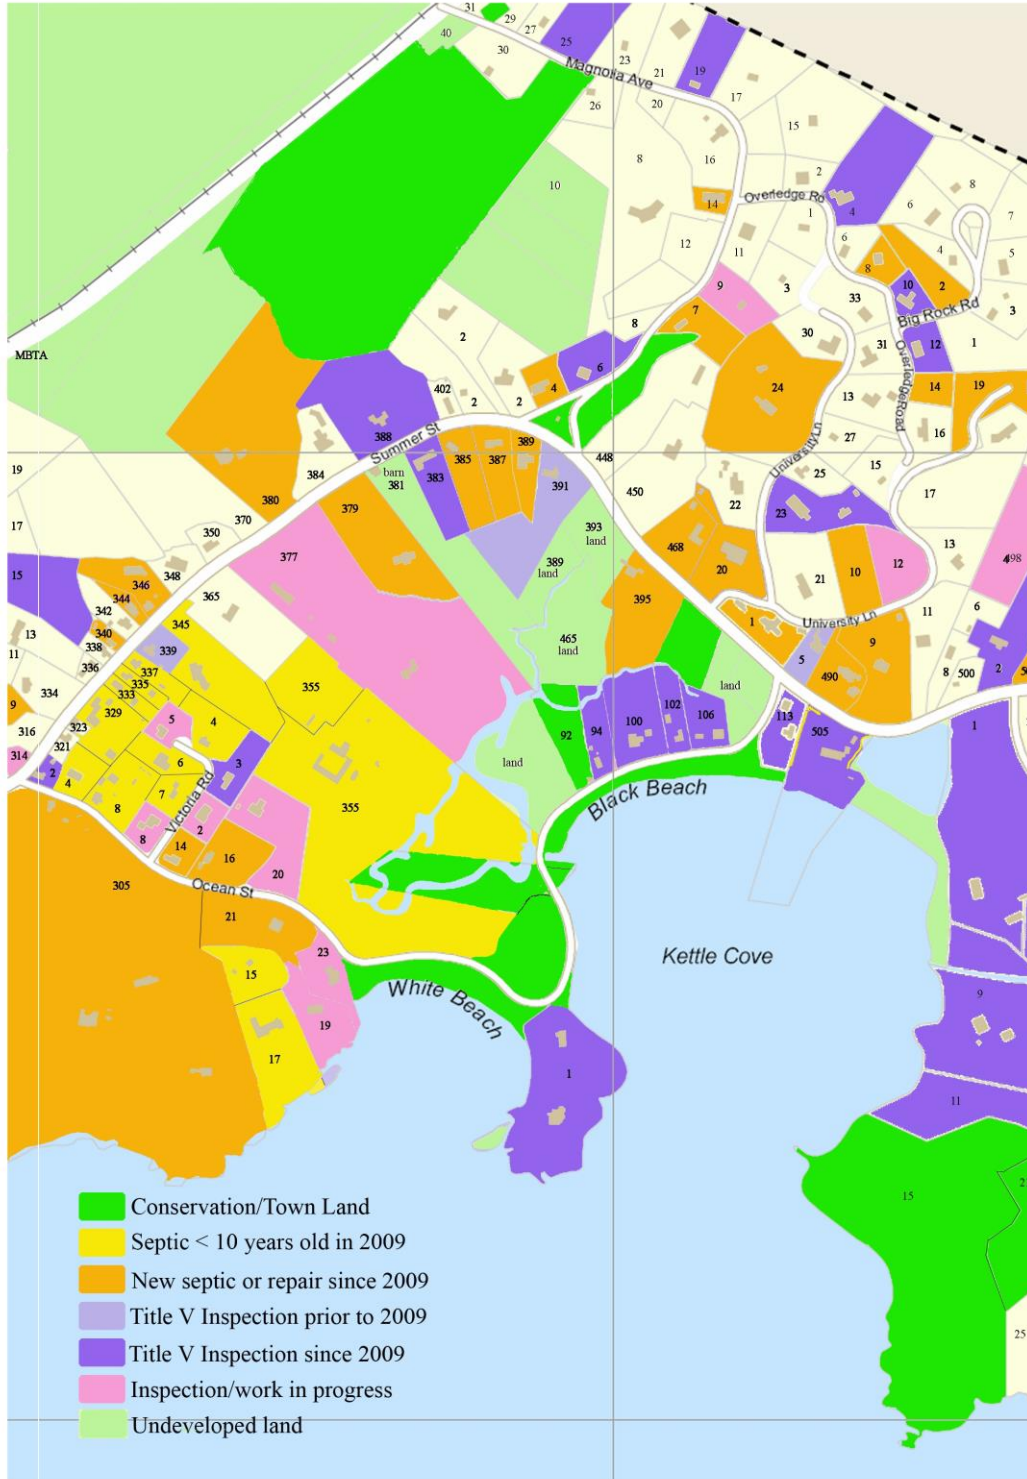
Figure 1: Map of Kettle Cove Septic Systems January 2015 from the Board of Health

Failing septic systems in the watershed were considered a possible source of bacterial contamination as well as the presence of wildlife and pet feces being washed into the brooks during rain events. Because the Wolf Trap estuary has 68 septic systems in its immediate watershed (Figure 1 on page 9) and Title V only requires testing of septic systems on the sale of property, in the spring of 2009, the Town Meeting passed the following action:
